BALLISTIC TESTING OF AGED NIEDNER RIFTS CONDUIT

INTERIM REPORT TFLRF No. 431

U.S. Army TARDEC Fuels and Lubricants Research Facility Southwest Research Institute[®] (SwRI[®])
San Antonio, TX

Contract No. W56HZV-09-C-0100 (WD15-Task 5)

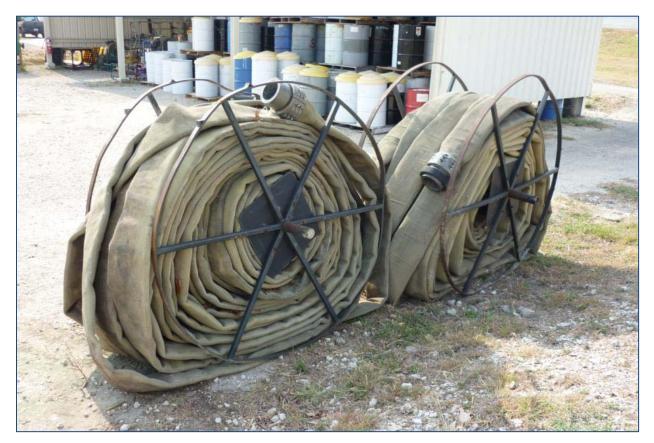
The two reels of hose delivered to SwRI from Fort Lee are shown in Figure 1. The hoses were soiled but appeared to be in otherwise good condition.

Figure 1. Niedner Hose Reels as Delivered to SwRI

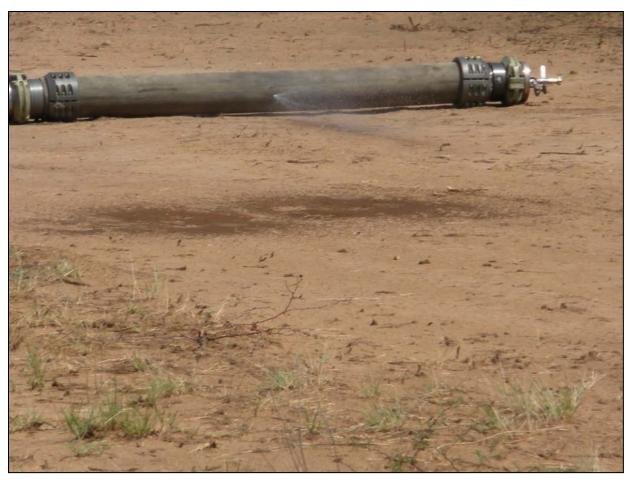
Post impact inspection indicated that penetration had occurred and the slug had exited on the opposite side, as shown in Figure 2.

Figure 2. .308 Caliber, 90° Impact

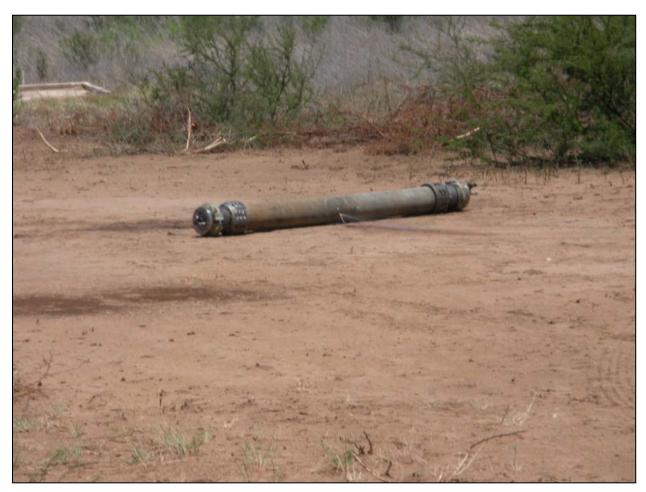
Post impact inspection indicated that penetration had occurred and the slug had exited on the opposite side, as shown in Figure 3.

Figure 3. .308 Caliber, 45° Impact

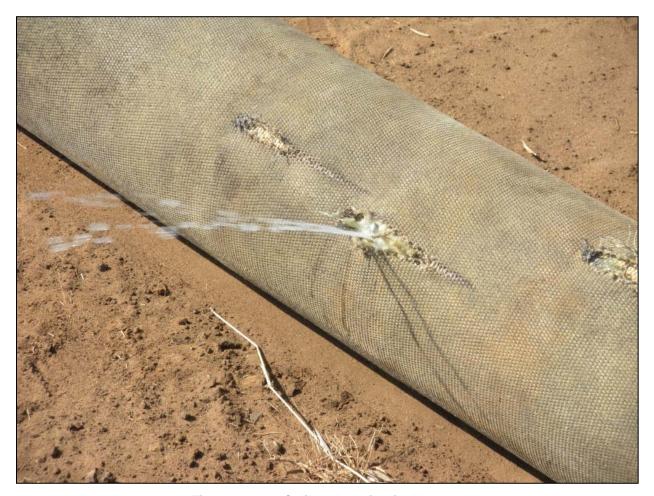
Post impact inspection indicated that only after the second impact at the same point did penetration occur but did not exit the opposite side of the hose, as shown in Figure 4.

Figure 4. .308 Caliber, Longitudinal Impact

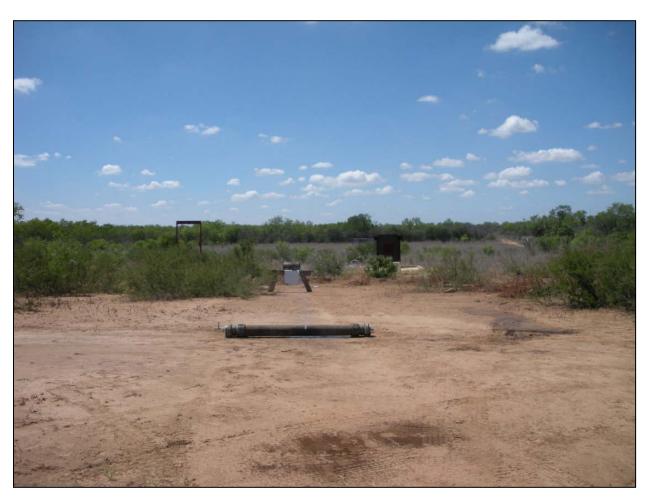
Post impact inspection indicated that penetration had occurred but did not exit on the opposite side, as shown in Figure 5.

Figure 5. .223 Caliber, 90° Impact

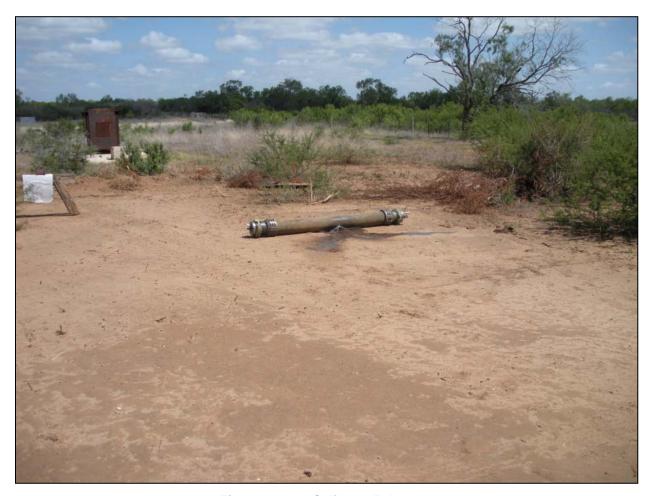
Post impact inspection indicated that penetration had occurred but did not exit on the opposite side, as shown in Figure 6.

Figure 6. .223 Caliber, 45° Impact

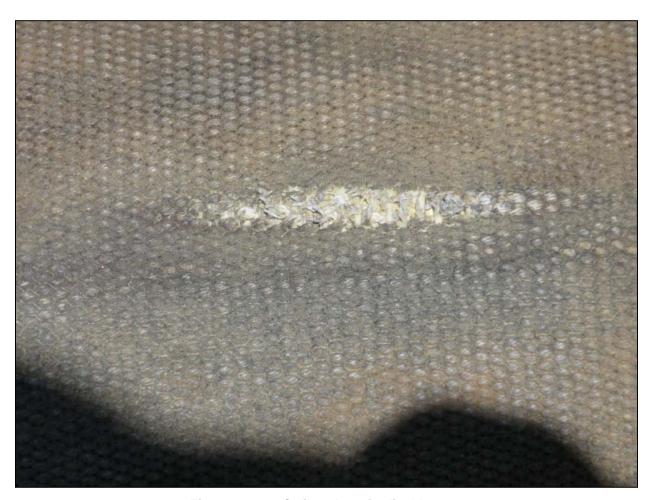
Caliber 223, Longitudinal Impact

Post impact inspection indicated that penetration had not occurred following impact, as shown in Figure 7.

Figure 7. .223 Caliber, Longitudinal Impact

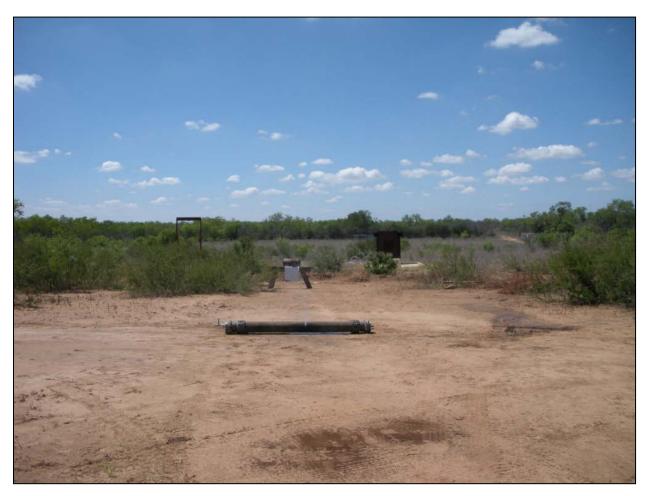
Post impact inspection indicated that penetration had occurred but did not exit on the opposite side, as shown Figure 8.

Figure 8. 9 mm, 90° Impact

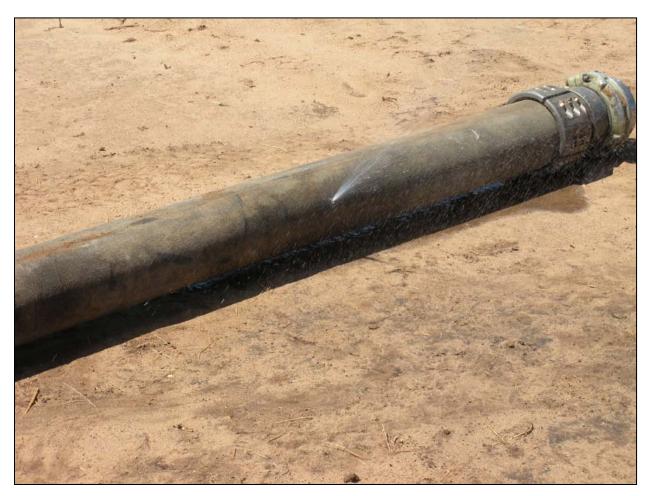
9 mm, 45 ° Impact

Post impact inspection indicated that penetration had occurred but did not exit on the opposite side, as shown in Figure 9.

Figure 9. 9 mm, 45° Impact

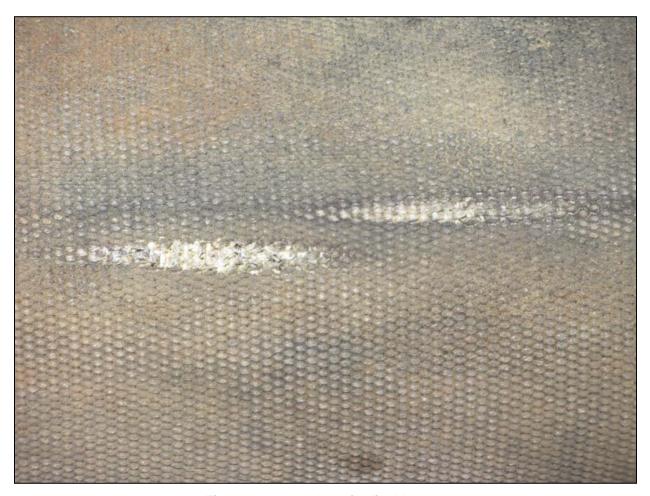
Post impact inspection indicated that following impact, penetration had not occurred, as shown in Figure 10.

Figure 10. 9 mm, Longitudinal Impact

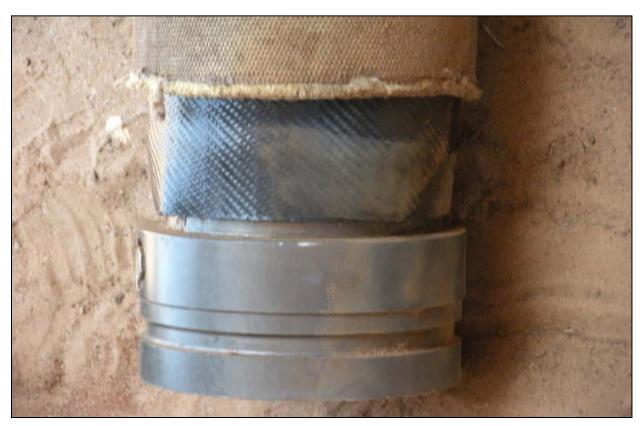
It was noted while the hose sections were being prepared for testing that the inner liner randomly extended beyond the Aramid jacket of the 6 ft sections of hose that were to be used in the ballistic testing. Figure 11 shows approximately a $1\frac{1}{2}$ –2 inch extension beyond the Aramid jacket. This was not easily explainable since this was only a 6 ft piece of hose cut with a horizontal band saw. There were still several sections that had not been tested. Figure 12 shows a distinct random expansion in sections of hose that came from the same hose reel. It was theorized that this hose expansion, with both ends clamped on the end coupling, demonstrates the theory of hose bunching, preventing the fuel from being pushed through to empty the hose prior to placing in on the reel.

Figure 11. Niedner Rifts Conduit Liner Extending 1½-2" beyond the Aramid Jacket

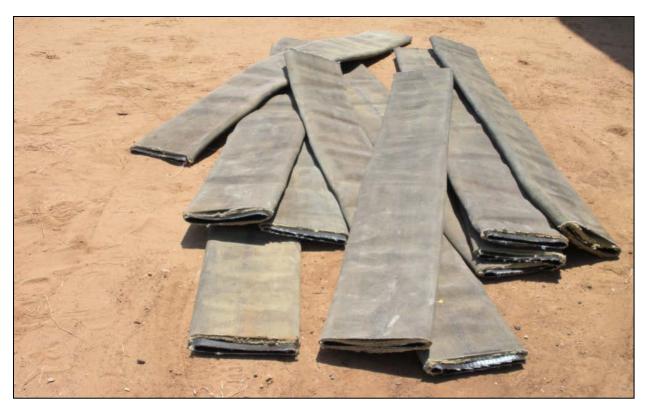
Figure 12. Niedner Rifts Conduit Liner from Same Reel with Random Expansion
